HOME REPORT

ROSEDALE
78 MAIN STREET
ISLE OF WHITHORN
NEWTON STEWART
DG8 8LG

Energy Performance Certificate (EPC)

Single Survey

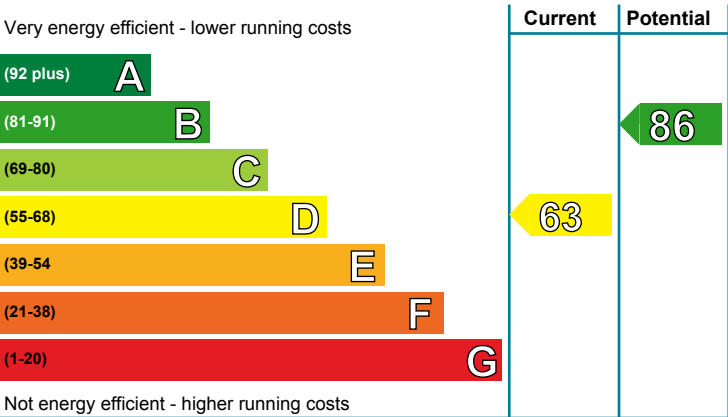
Energy Efficiency Rating

This graph shows the current efficiency of your home, taking into account both energy efficiency and fuel costs. The higher this rating, the lower your fuel bills are likely to be.

Your current rating is **band D (63)**. The average rating for EPCs in Scotland is **band D (61)**.

The potential rating shows the effect of undertaking all of the improvement measures listed within your recommendations report.

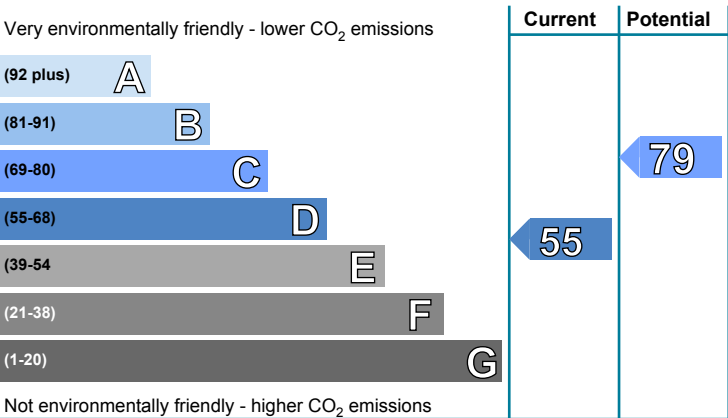
Environmental Impact (CO₂) Rating

This graph shows the effect of your home on the environment in terms of carbon dioxide (CO₂) emissions. The higher the rating, the less impact it has on the environment.

Your current rating is **band D (55)**. The average rating for EPCs in Scotland is **band D (59)**.

The potential rating shows the effect of undertaking all of the improvement measures listed within your recommendations report.
