Home Report

Single Survey

Property address	1 Hillhead Cottages Wigtown Newton Stewart DG8 9BA
Customer	Mr & Mrs Graham Vosper
Customer address	1 Hillhead Cottages Wigtown Newton Stewart DG8 9BA
Prepared by	Shepherd Chartered Surveyors
Date of inspection	14/05/2025

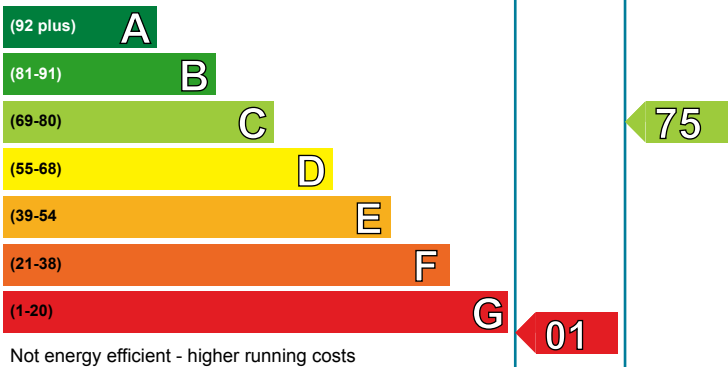
Energy Efficiency Rating

This graph shows the current efficiency of your home, taking into account both energy efficiency and fuel costs. The higher this rating, the lower your fuel bills are likely to be.

The potential rating shows the effect of undertaking all of the improvement measures listed within your recommendations report.

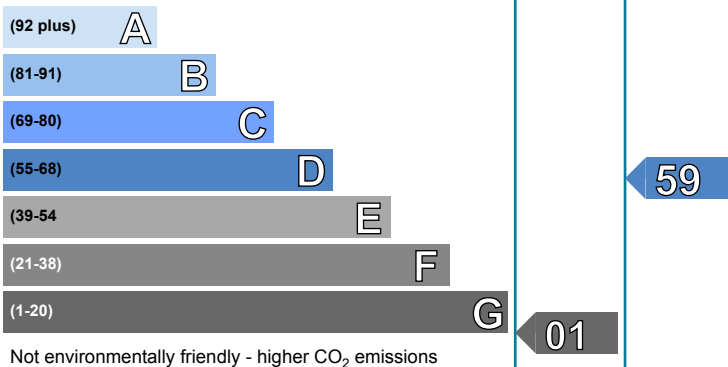
Environmental Impact (CO₂) Rating

This graph shows the effect of your home on the environment in terms of carbon dioxide (CO₂) emissions. The higher the rating, the less impact it has on the environment.
