Home Report

Scottish Single Survey

Single Survey

| Property address | 13 St. John Street Whithorn Newton Stewart DG8 8PD |

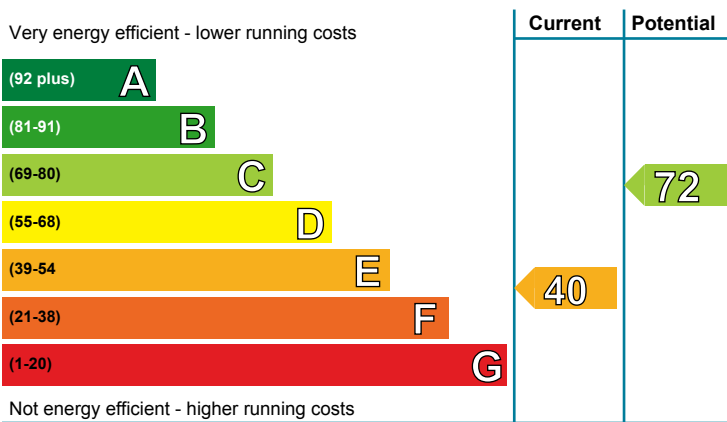
Energy Efficiency Rating

This graph shows the current efficiency of your home, taking into account both energy efficiency and fuel costs. The higher this rating, the lower your fuel bills are likely to be.

Your current rating is **band E (40)**. The average rating for EPCs in Scotland is **band D (61)**.

The potential rating shows the effect of undertaking all of the improvement measures listed within your recommendations report.

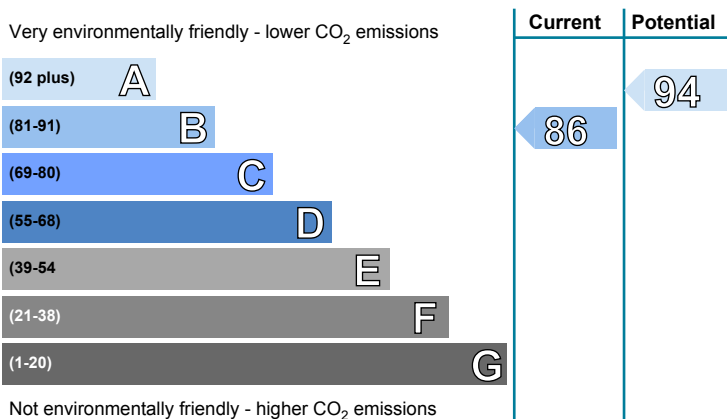
Environmental Impact (CO₂) Rating

This graph shows the effect of your home on the environment in terms of carbon dioxide (CO₂) emissions. The higher the rating, the less impact it has on the environment.
