Home Report

Single Survey

Property address	Glen Maree Monreith Newton Stewart DG8 9LW
-------------------------	---

Prepared by	Shepherd Chartered Surveyors
--------------------	------------------------------

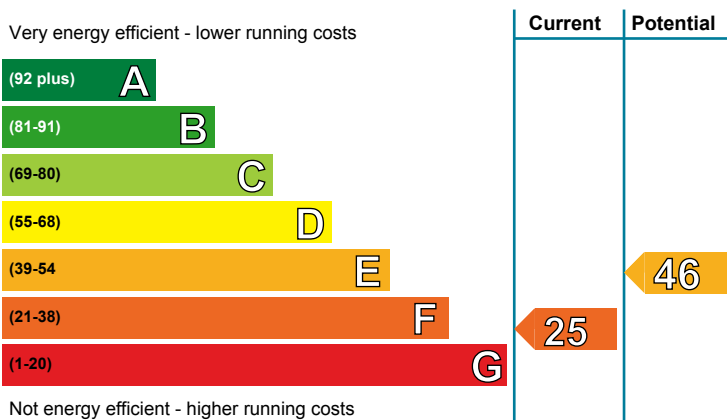
Energy Efficiency Rating

This graph shows the current efficiency of your home, taking into account both energy efficiency and fuel costs. The higher this rating, the lower your fuel bills are likely to be.

Your current rating is **band F (25)**. The average rating for EPCs in Scotland is **band D (61)**.

The potential rating shows the effect of undertaking all of the improvement measures listed within your recommendations report.

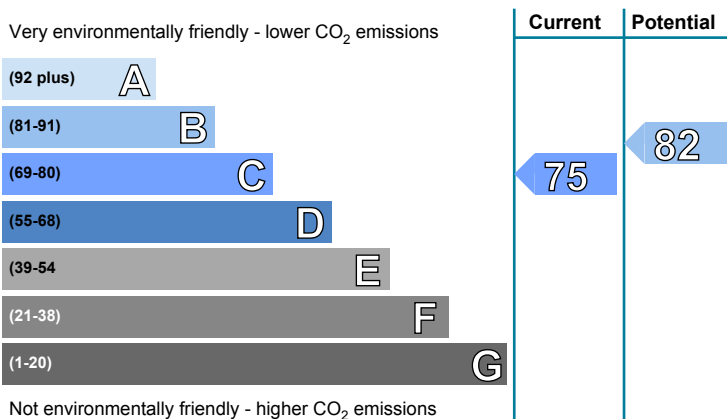
Environmental Impact (CO₂) Rating

This graph shows the effect of your home on the environment in terms of carbon dioxide (CO₂) emissions. The higher the rating, the less impact it has on the environment.
