Griffin Lodge,
Port William,
NEWTON STEWART,
DG8 9QN

Home Report

Single Survey

Property Address	Griffin Lodge, Port William, NEWTON STEWART, DG8 9QN
Reference	1585406
Customer Name	Brian Smith Executry
Date of Inspection	26th May 2026
Surveyor's name, qualifications and office	Michael P Churm BSc (Hon's) MRICS DM Hall LLP Chartered Surveyors 11 Buccleuch Street Dumfries DG1 2AT Tel: 01387 254318 email: dumfriesresidential@dmhall.co.uk
Prepared By	DM Hall LLP

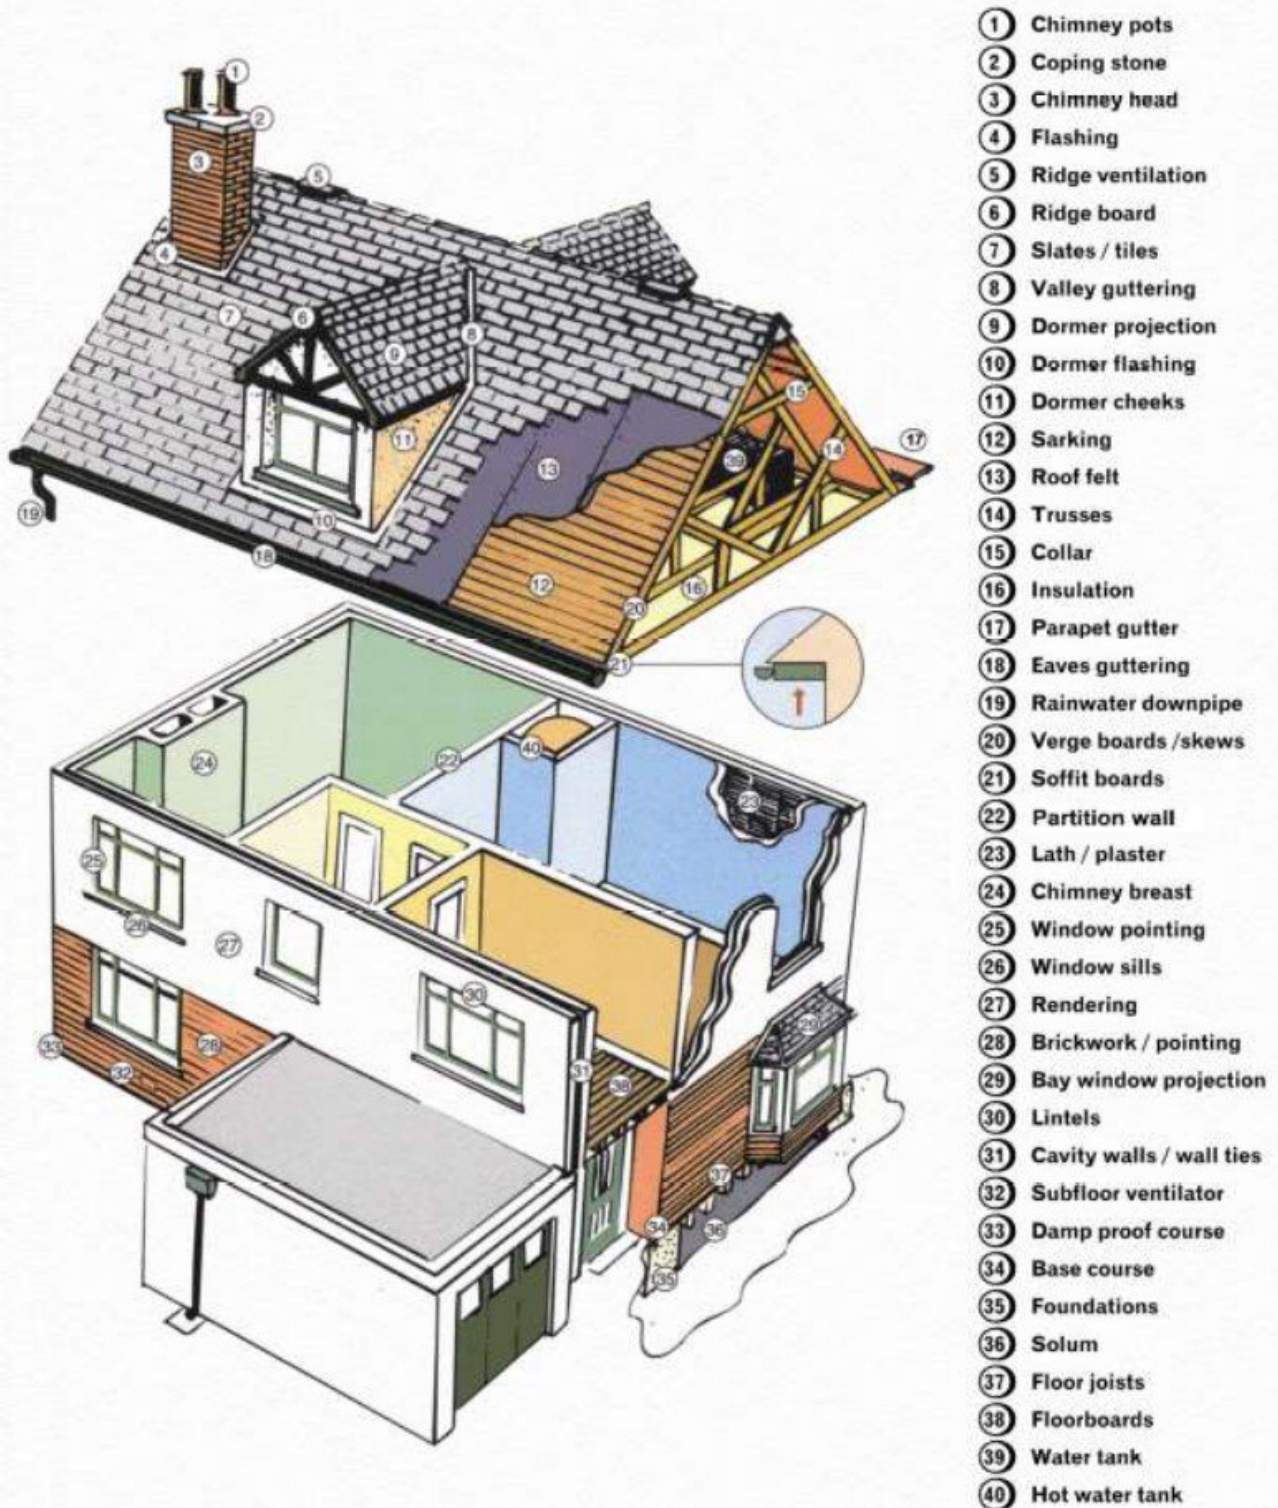
Sectional Diagram showing elements of a typical house

Reference may be made in this report to some or all of the above component parts of the property. This diagram may assist you in locating and understanding these items.

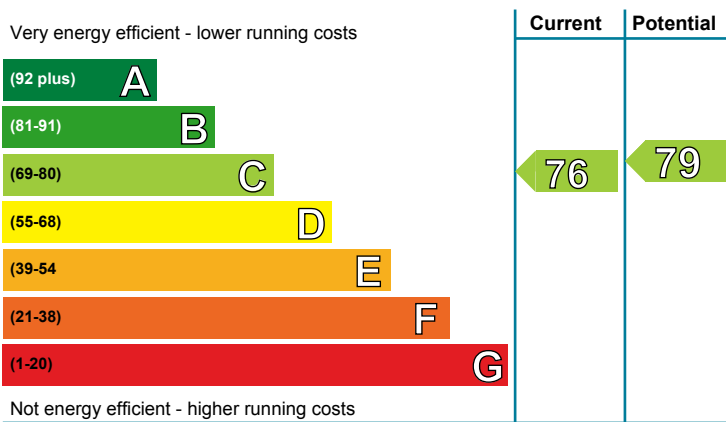
Energy Efficiency Rating

This graph shows the current efficiency of your home, taking into account both energy efficiency and fuel costs. The higher this rating, the lower your fuel bills are likely to be.

Your current rating is **band C (76)**. The average rating for EPCs in Scotland is **band D (61)**.

The potential rating shows the effect of undertaking all of the improvement measures listed within your recommendations report.

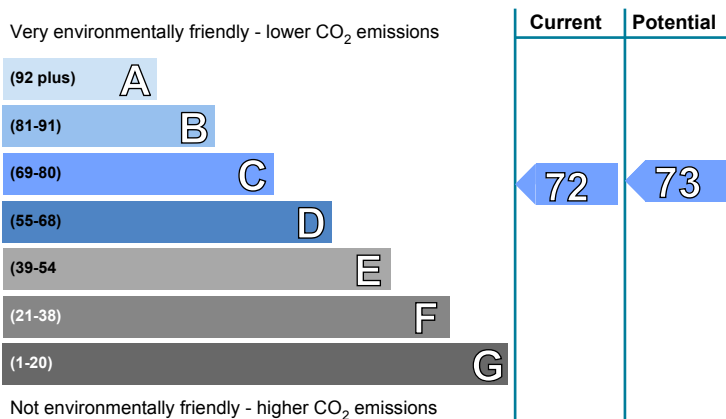
Environmental Impact (CO₂) Rating

This graph shows the effect of your home on the environment in terms of carbon dioxide (CO₂) emissions. The higher the rating, the less impact it has on the environment.
