Home Report

Scottish Single Survey

Single Survey

Property address	Pulquat Cottage Creetown Newton Stewart DG8 7DE
-------------------------	--

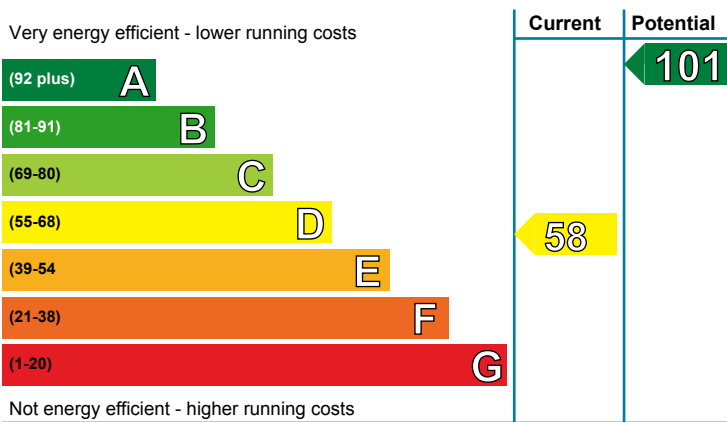
Energy Efficiency Rating

This graph shows the current efficiency of your home, taking into account both energy efficiency and fuel costs. The higher this rating, the lower your fuel bills are likely to be.

Your current rating is **band D (58)**. The average rating for EPCs in Scotland is **band D (61)**.

The potential rating shows the effect of undertaking all of the improvement measures listed within your recommendations report.

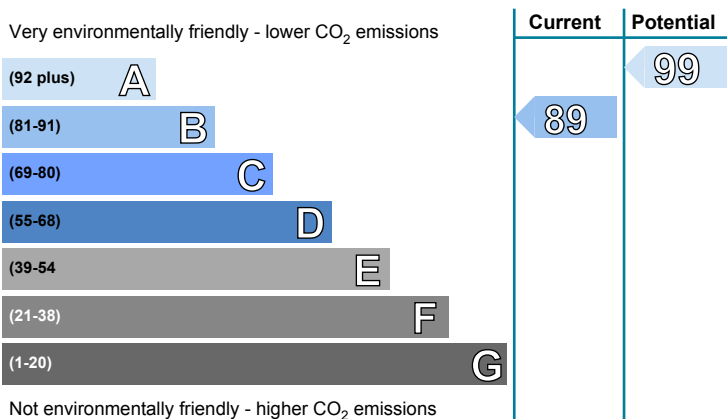
Environmental Impact (CO₂) Rating

This graph shows the effect of your home on the environment in terms of carbon dioxide (CO₂) emissions. The higher the rating, the less impact it has on the environment.
