Home Report

Single Survey

survey report on:

Property address	Seven Oaks Main Street Glenluce Newton Stewart DG8 0PN
Customer	Mr Ean Stewart
Customer address	Seven Oaks Main Street Glenluce Newton Stewart DG8 0PN
Prepared by	Shepherd Chartered Surveyors
Date of inspection	05/02/2026

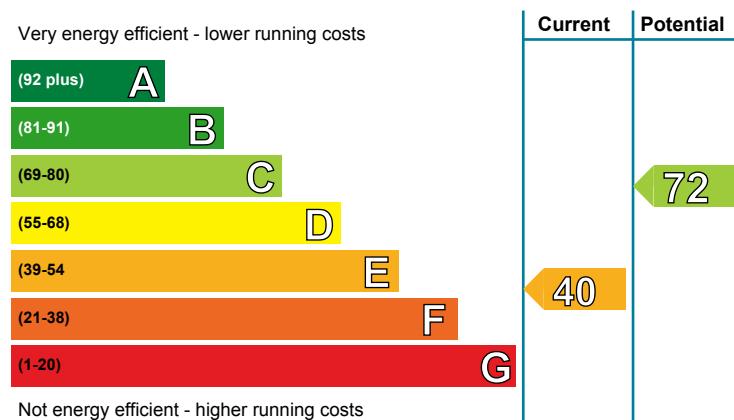
Energy Efficiency Rating

This graph shows the current efficiency of your home, taking into account both energy efficiency and fuel costs. The higher this rating, the lower your fuel bills are likely to be.

Your current rating is **band E (40)**. The average rating for EPCs in Scotland is **band D (61)**.

The potential rating shows the effect of undertaking all of the improvement measures listed within your recommendations report.

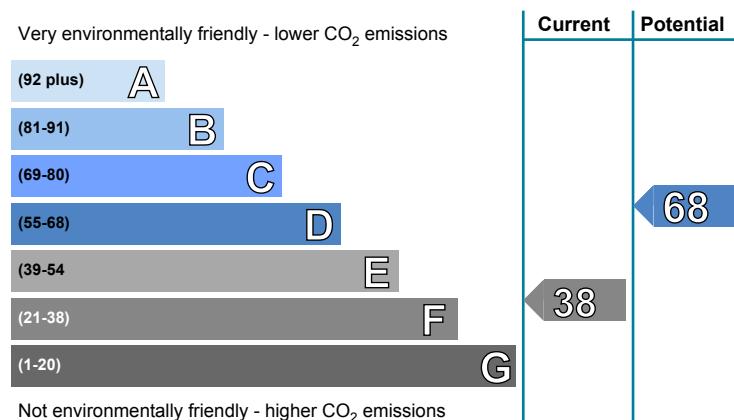
Environmental Impact (CO₂) Rating

This graph shows the effect of your home on the environment in terms of carbon dioxide (CO₂) emissions. The higher the rating, the less impact it has on the environment.
