YOUR ONESURVEY HOME REPORT

Sunnybrae
High Street
Wigtown
Newton Stewart, DG8 9EQ

HOME REPORT

SINGLE SURVEY

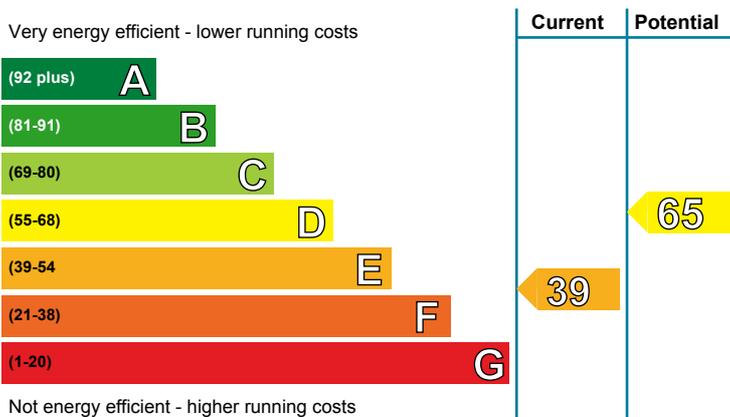
Energy Efficiency Rating

This graph shows the current efficiency of your home, taking into account both energy efficiency and fuel costs. The higher this rating, the lower your fuel bills are likely to be.

Your current rating is **band E (39)**. The average rating for EPCs in Scotland is **band D (61)**.

The potential rating shows the effect of undertaking all of the improvement measures listed within your recommendations report.

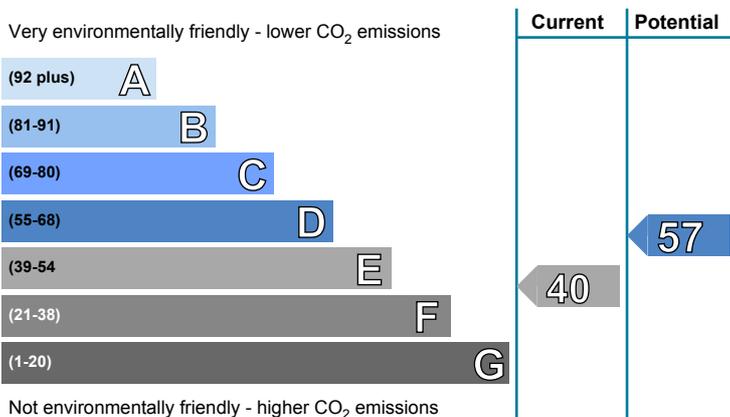
Environmental Impact (CO₂) Rating

This graph shows the effect of your home on the environment in terms of carbon dioxide (CO₂) emissions. The higher the rating, the less impact it has on the environment.
