# Home Report

# Single Survey

<b>Property address</b>	Thistledown Cottage Kirkinner Newton Stewart DG8 9AL
<b>Customer</b>	The Late Christine Jones
<b>Customer address</b>	Thistledown Cottage Kirkinner Newton Stewart DG8 9AL
<b>Prepared by</b>	Shepherd Chartered Surveyors
<b>Date of inspection</b>	09/02/2026

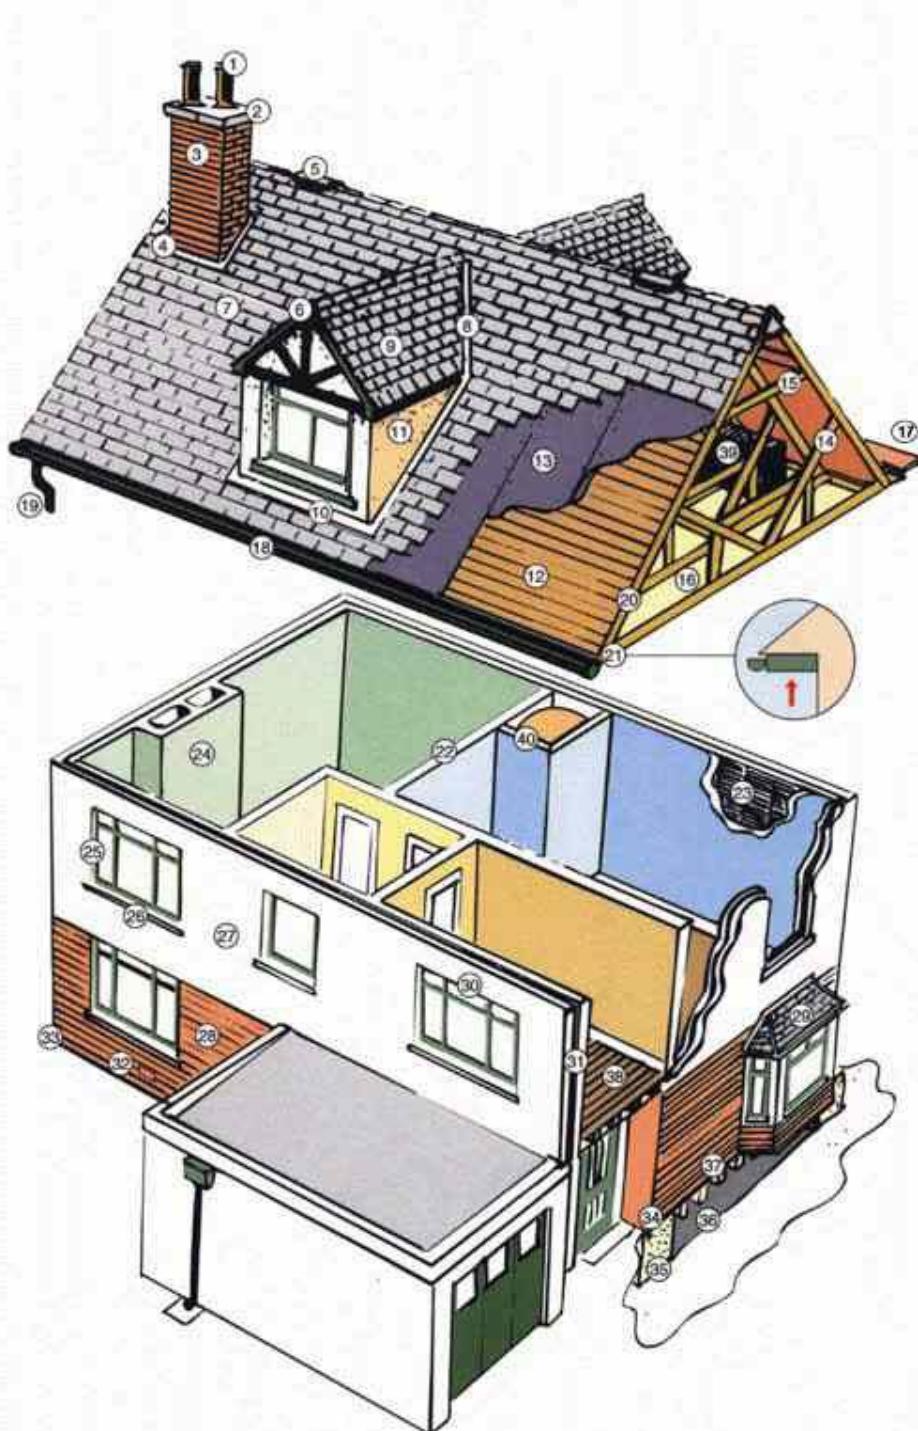
## Sectional Diagram showing elements of a typical house

- 1 Chimney pots
- 2 Coping stone
- 3 Chimney head
- 4 Flashing
- 5 Ridge ventilation
- 6 Ridge board
- 7 Slates / tiles
- 8 Valley guttering
- 9 Dormer projection
- 10 Dormer flashing
- 11 Dormer cheeks
- 12 Sarking
- 13 Roof felt
- 14 Trusses
- 15 Collar
- 16 Insulation
- 17 Parapet gutter
- 18 Eaves guttering
- 19 Rainwater downpipe
- 20 Verge boards /skews
- 21 Soffit boards
- 22 Partition wall
- 23 Lath / plaster
- 24 Chimney breast
- 25 Window pointing
- 26 Window sills
- 27 Rendering
- 28 Brickwork / pointing
- 29 Bay window projection
- 30 Lintels
- 31 Cavity walls / wall ties
- 32 Subfloor ventilator
- 33 Damp proof course
- 34 Base course
- 35 Foundations
- 36 Solum
- 37 Floor joists
- 38 Floorboards
- 39 Water tank
- 40 Hot water tank

Reference may be made in this report to some or all of the above component parts of the property. This diagram may assist you in locating and understanding these items.

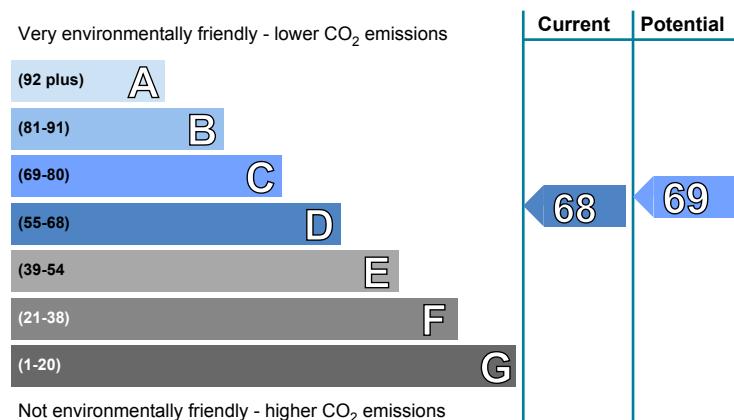
## Environmental Impact (CO<sub>2</sub>) Rating

This graph shows the effect of your home on the environment in terms of carbon dioxide (CO<sub>2</sub>) emissions. The higher the rating, the less impact it has on the environment.
