Home Report

Single Survey

Property address	17 Main Street New Luce Newton Stewart DG8 0AJ
Customer	Mrs Lorraine Durose
Customer address	17 Main Street New Luce Newton Stewart DG8 0AJ
Prepared by	Shepherd Chartered Surveyors
Date of inspection	27/11/2025

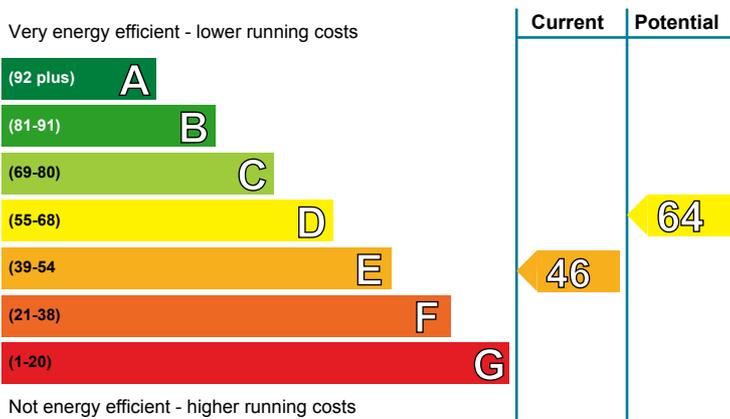
Energy Efficiency Rating

This graph shows the current efficiency of your home, taking into account both energy efficiency and fuel costs. The higher this rating, the lower your fuel bills are likely to be.

Your current rating is **band E (46)**. The average rating for EPCs in Scotland is **band D (61)**.

The potential rating shows the effect of undertaking all of the improvement measures listed within your recommendations report.

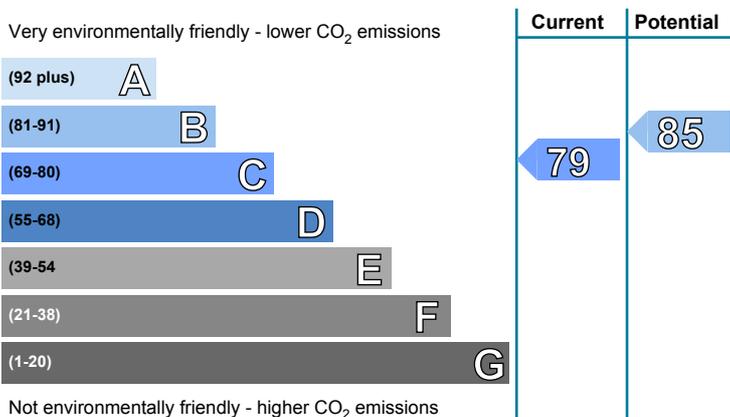
Environmental Impact (CO₂) Rating

This graph shows the effect of your home on the environment in terms of carbon dioxide (CO₂) emissions. The higher the rating, the less impact it has on the environment.
