Home Report

Scottish Single Survey

Property address	The New House St Medans Monreith Newton Stewart DG8 9LJ
Customer	Mr Errol MacDonald
Customer address	The New House St Medans Monreith Newton Stewart DG8 9LJ
Prepared by	Shepherd Chartered Surveyors
Date of inspection	01/08/2023

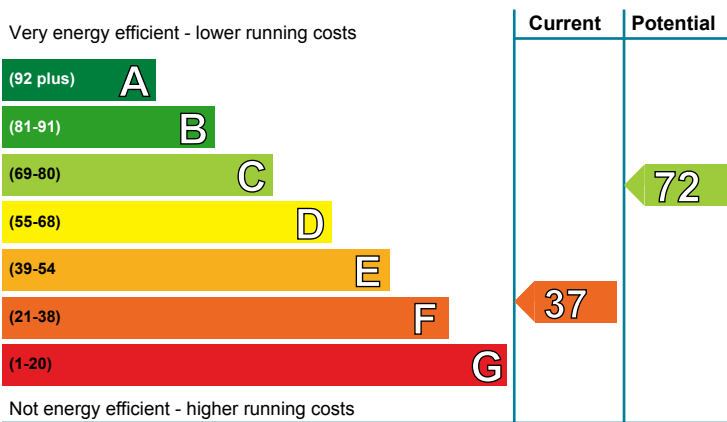
Energy Efficiency Rating

This graph shows the current efficiency of your home, taking into account both energy efficiency and fuel costs. The higher this rating, the lower your fuel bills are likely to be.

Your current rating is **band F (37)**. The average rating for EPCs in Scotland is **band D (61)**.

The potential rating shows the effect of undertaking all of the improvement measures listed within your recommendations report.

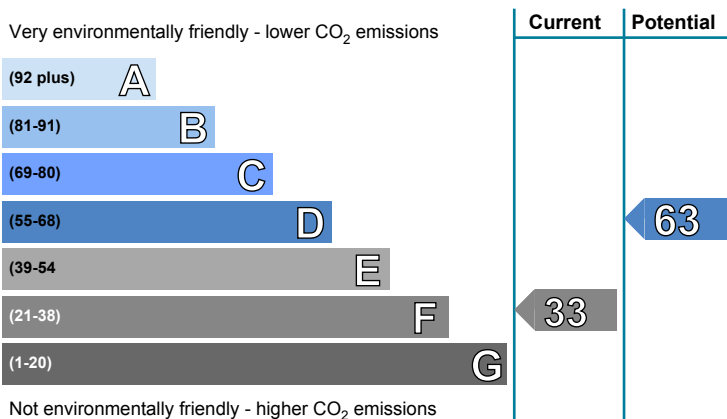
Environmental Impact (CO₂) Rating

This graph shows the effect of your home on the environment in terms of carbon dioxide (CO₂) emissions. The higher the rating, the less impact it has on the environment.
